Kaercher Creek Park

**Kaercher Creek Park
Hazardous Contamination Remediation
PFBC & Berks County
Proposed Work Plan**

FINAL TRIP REPORT

KAERCHER CREEK PARK REMOVAL ASSESSMENT AND EXTENT OF CONTAMINATION INVESTIGATION KAERCHER CREEK PARK – LAKE SITE WINDSOR TOWNSHIP, BERKS COUNTY, PENNSYLVANIA

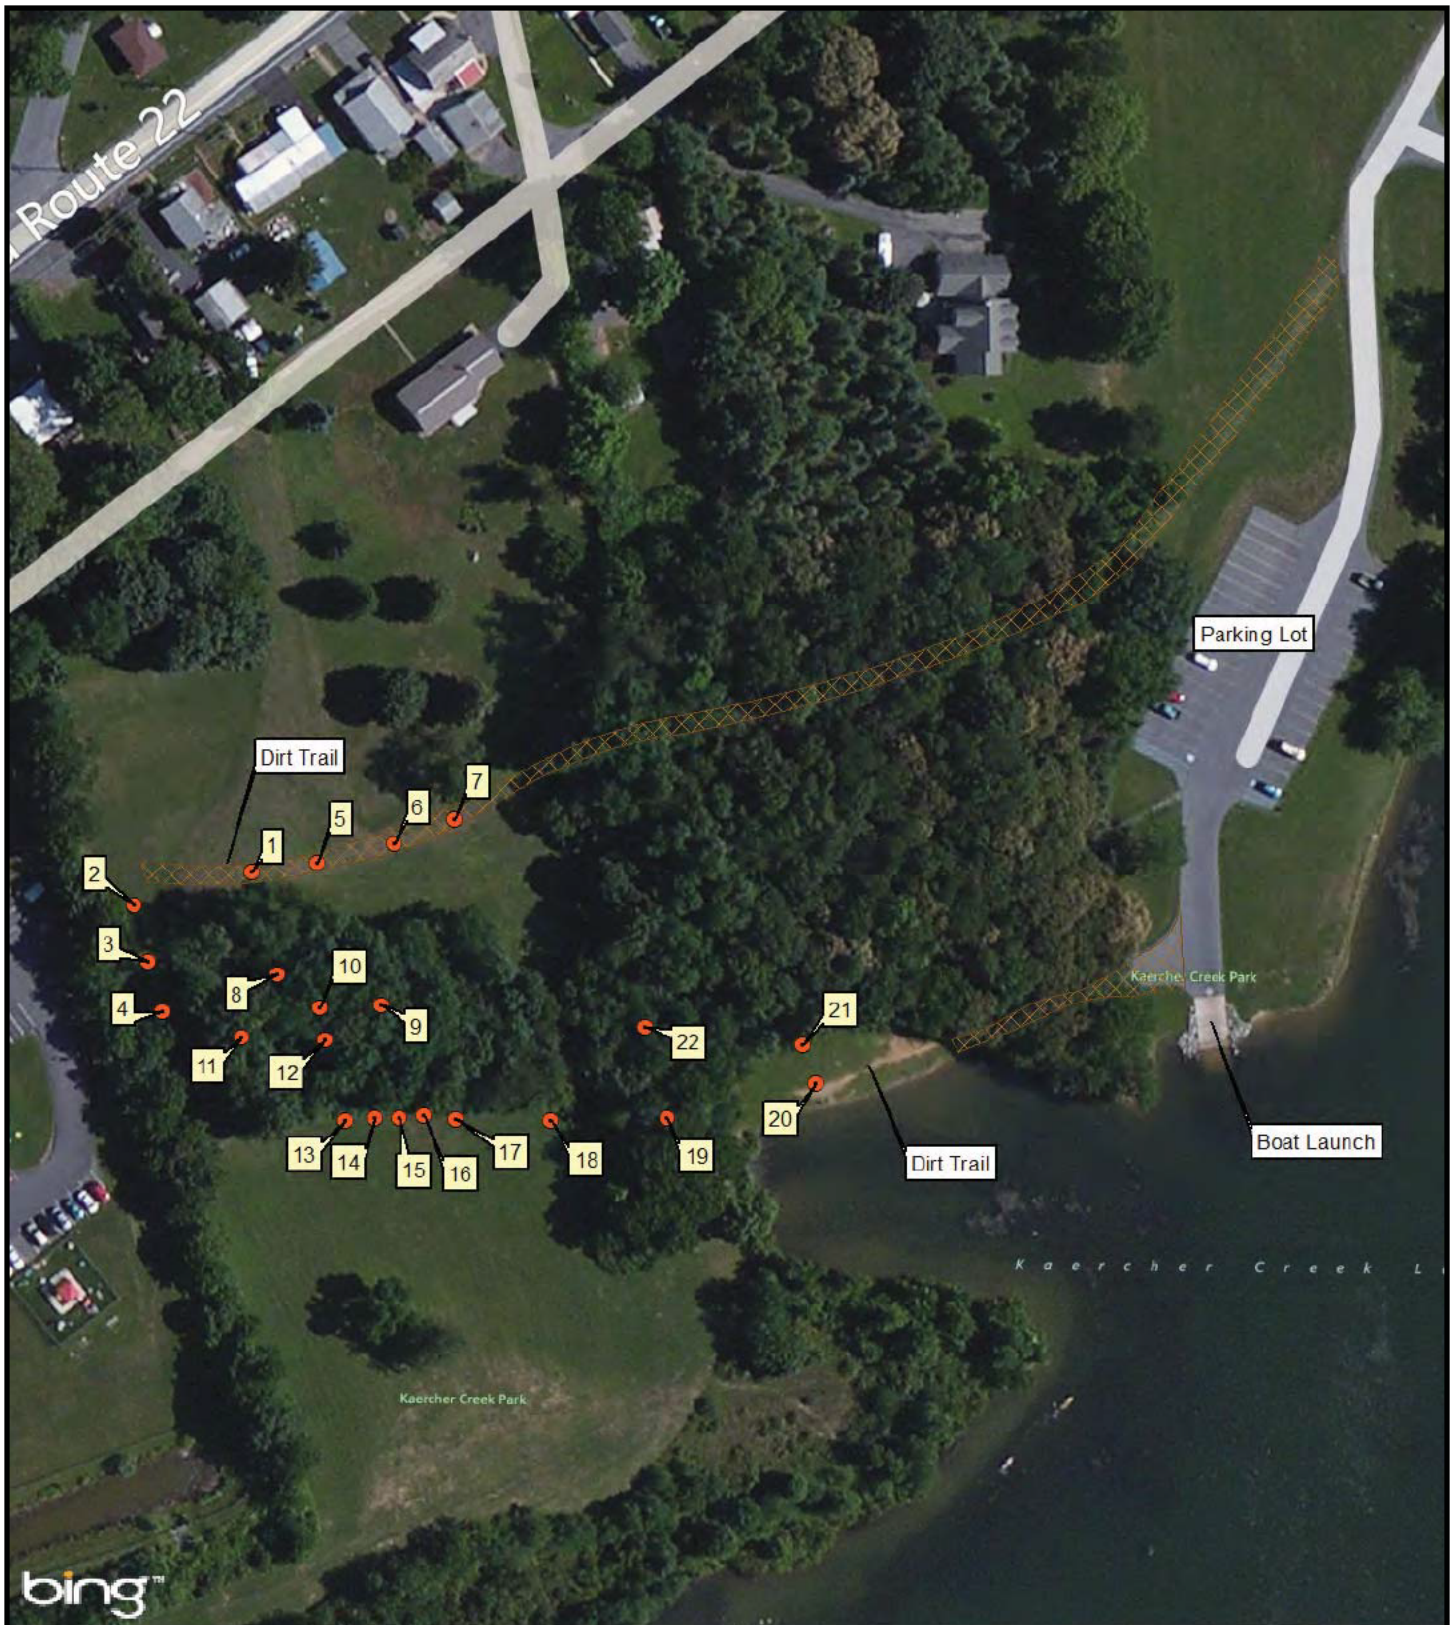
Figure 2
Test Pit Locations

Between July 30 and August 13, 2013, 22 test pits were excavated across the site. Test pits are identified on Figure 2, Test Pit Locations. During excavation of the test pits, soils were screened in-situ with an XRF to determine the depth and extent of lead contamination. Visual observations were made to determine the depth and extent of battery casing fragments. Composite soil samples were collected, dried, and screened ex-situ to provide replicable screening data for various areas. An in-situ survey of an area of the site was also conducted where exposed battery casing fragments were observed in surface soils. WESTON documented and photographed site activities in accordance with WESTON Standard Operating Procedure (SOP) No. 101, "Logbook Documentation" (WESTON 2006a). This section discusses soil investigation activities during this assessment.

A total of 22 test pits were excavated by WRScompass, an Emergency and Rapid Response Services contractor for EPA, to a depth of four feet using a mini-excavator. The test pits were excavated on the western and southern portions of the site, in locations that were suspected to contain battery casing fragments. Exact locations were selected by the EPA On-Scene Coordinator (OSC). Test pit locations were recorded using field measurements and landmarks and are identified on Figure 2, Test Pit Locations.

Each test pit was visually inspected for battery casings during excavation. Soil from the base of each test pit was collected in the excavator bucket, and screened for lead in the bucket using a handheld XRF analyzer. Results of test pit inspections and XRF analysis are presented in Table 1, Test Pit Results. Following the collection of data, test pits were backfilled with excavated material.

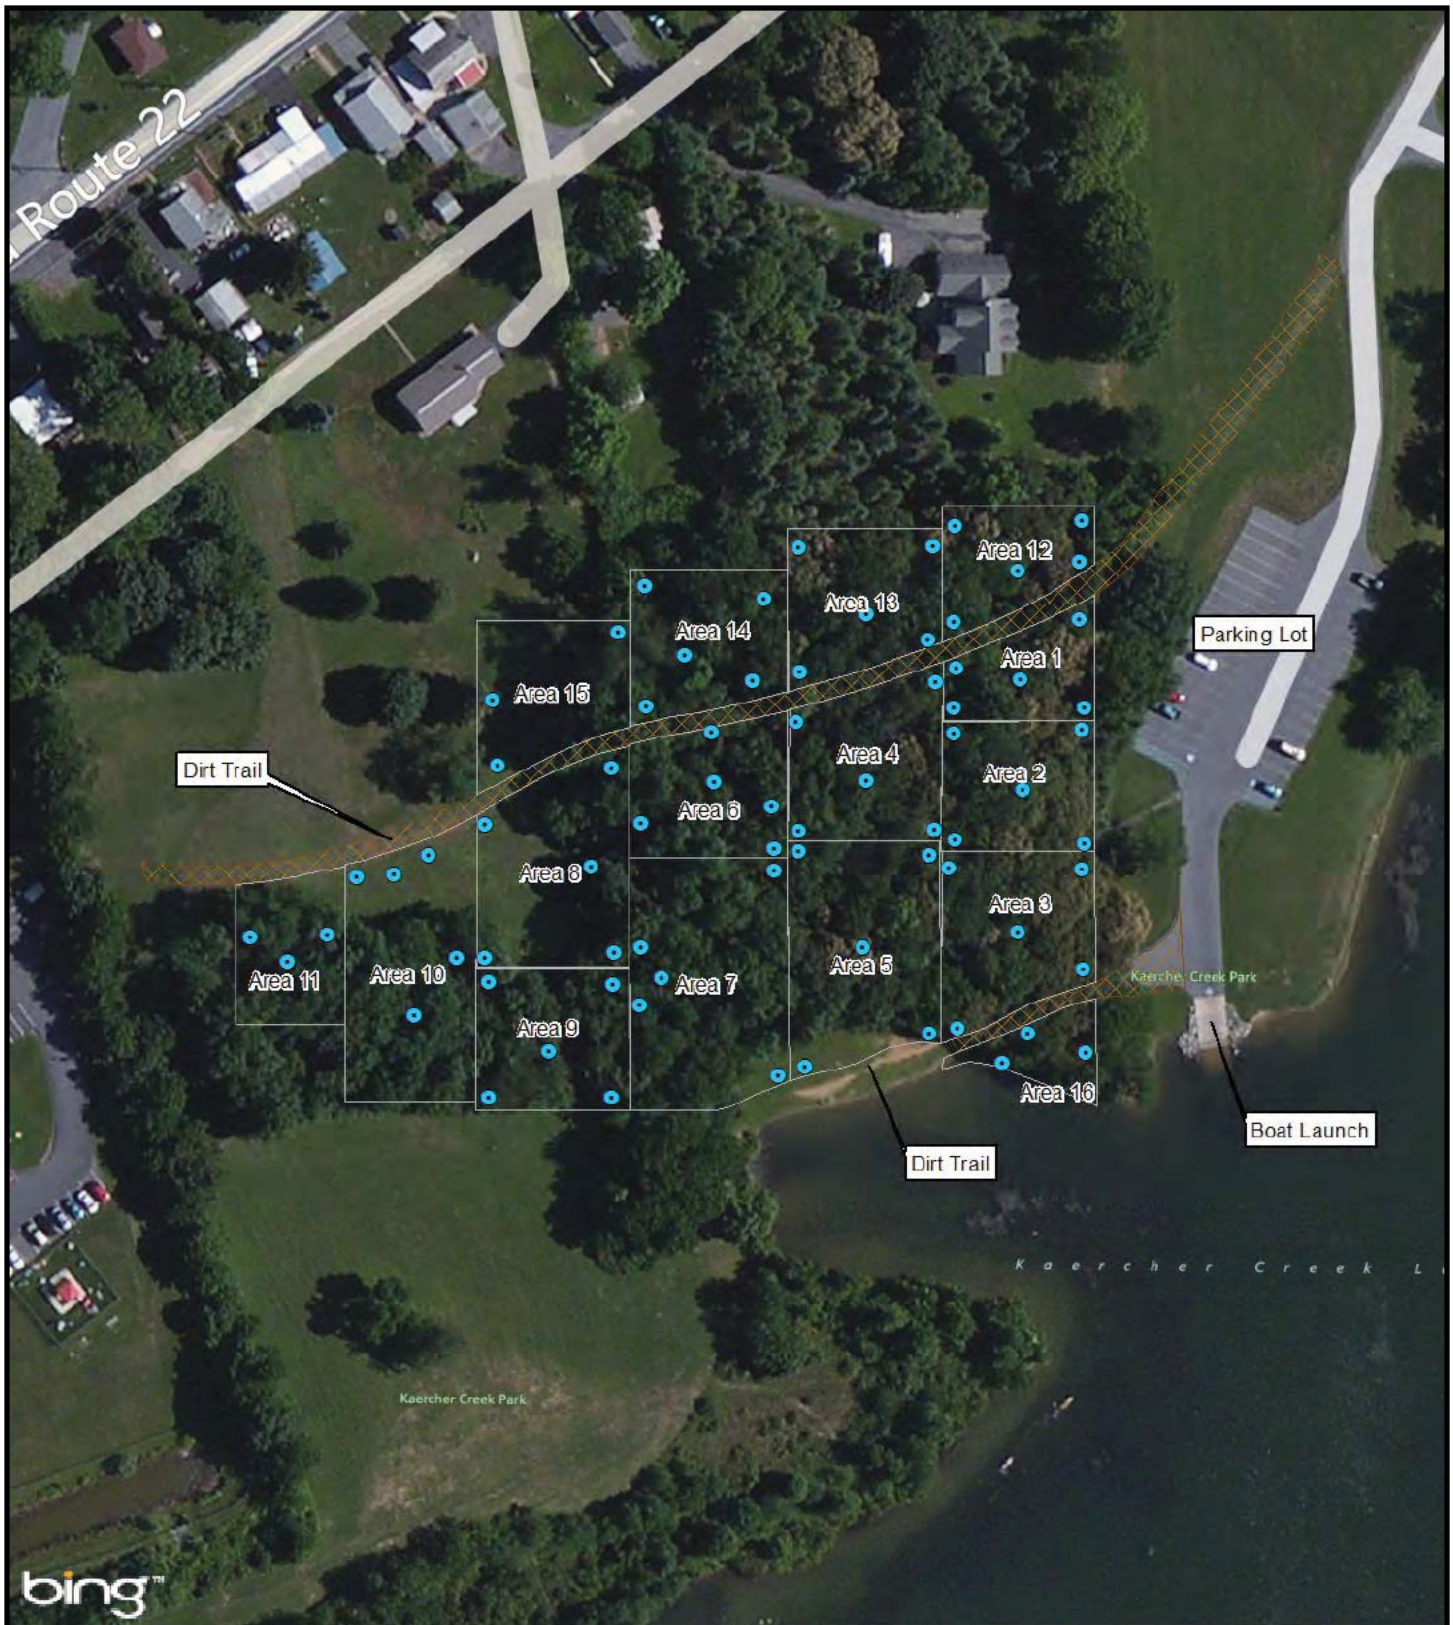
Results of ex-situ soil sample XRF screening are included in Table 2, Ex-Situ Soil Screening Results.

A portion of the site, located within Area 7, consisted of an exposed embankment of a hill where battery casing fragments were observed in surface soils. Surface soils were analyzed in-situ for lead using a hand held XRF analyzer. Prior to testing, locations were cleared of vegetation and

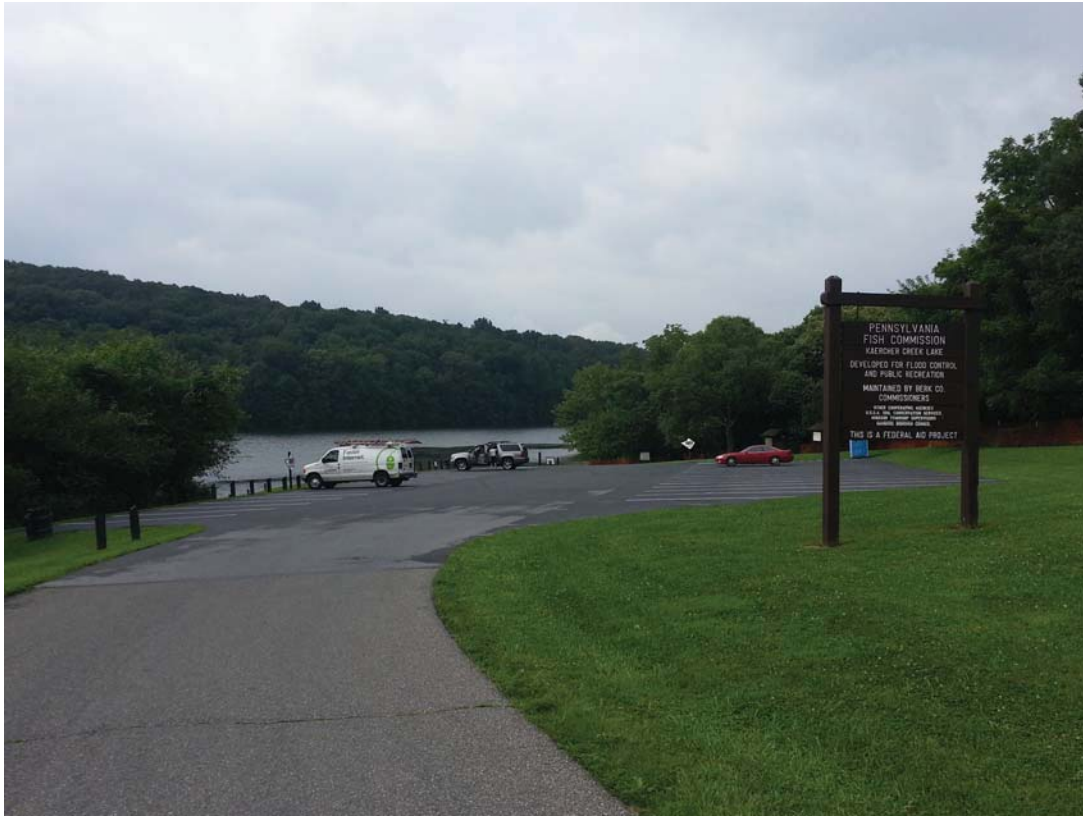
PHOTO 1: View of parking area east of site and lake beyond
